SAN FRANCISCO
PORT OF EMBARKATION
HISTORIC STRUCTURE REPORT

Golden Gate National Recreation Area
National Park Service

ARCHITECTURAL RESOURCES GROUP

February 1991

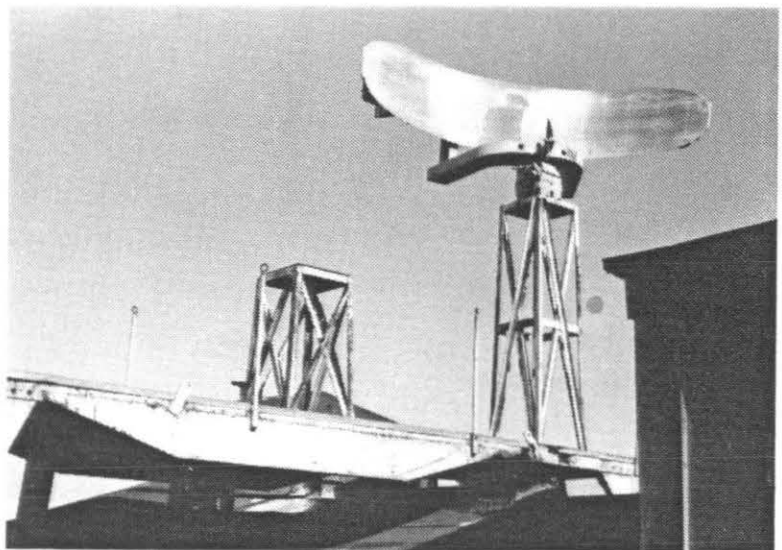
top -- Roof monitor and copper vent.
bottom -- Non-functioning radar equipment on Building 317.

1. Replace roof on Building 317. This will involve removing existing membrane down to wood decking. Inspect exposed decking and replace deteriorated wood. Replace roof with similar system. Bituminous paint should be used between dissimilar metals.
2. Check and clear obstructed roof drains on all buildings. Install drain screens where necessary. Check monthly for obstruction, and more frequently during periods of heavy rain.
3. Further study is necessary to determine the historic significance of the radar training school located in Building 317. The radar equipment mount on the north end of roof should remain in place until the study has been completed.

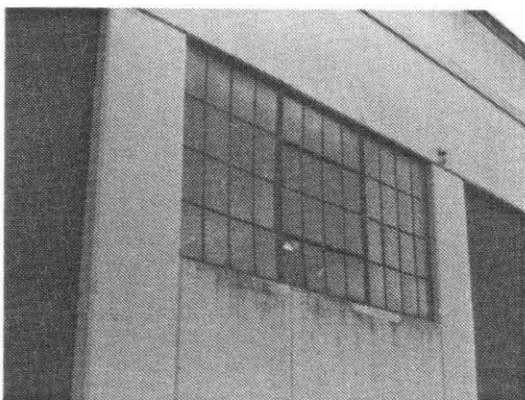
Factory sash in Pier Shed 3 with a bowed frame.

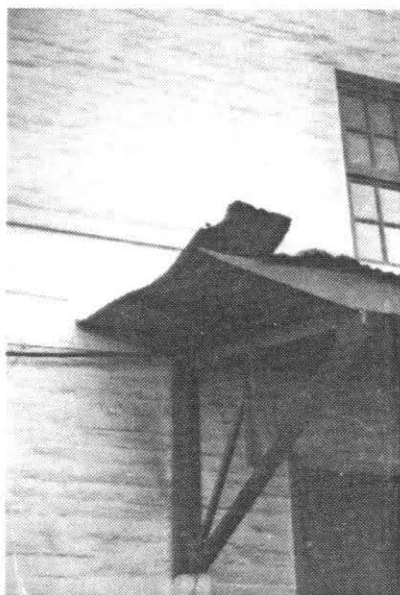
*Damaged awning on
Building 314*

1. Repair or replace deformed awning components.
2. Scrape loose or flaking paint and remove all corrosion from metal by wire brush.
3. Prime bare metal and paint all metal using appropriate coating of the same system for use on exterior ferrous metals. Finish coat color should match existing.
4. Check all metal biannually for any areas of corrosion. Remove corrosion and re-coated surface.
5. Areas where birds roost should be covered with specially manufactured bird netting sensitively installed.

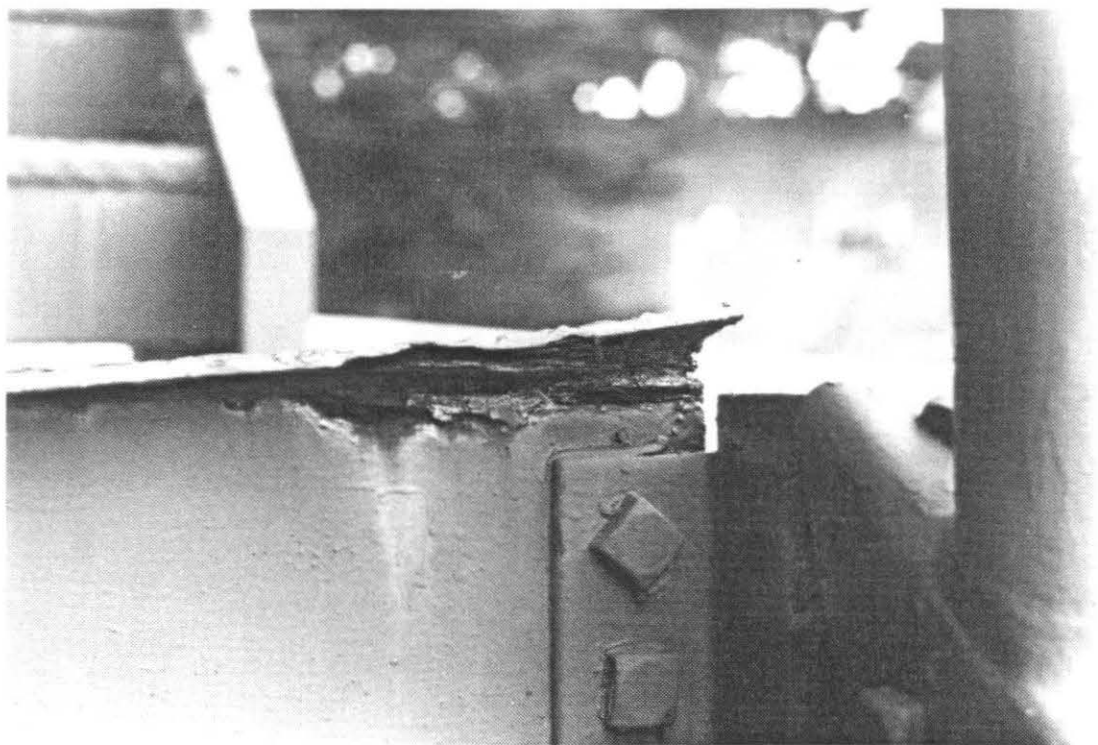
*Corroded section of
exterior stair landing.*

Fire escape stairways should be surveyed immediately and severely corroded portions repaired. This will involve removing steel that has lost more than 25% of its original dimension and replacing it with new steel welded into place. In some cases it may be more economical to replace entire stair runs. New steel and portions affected by repairs should be coated as described below.

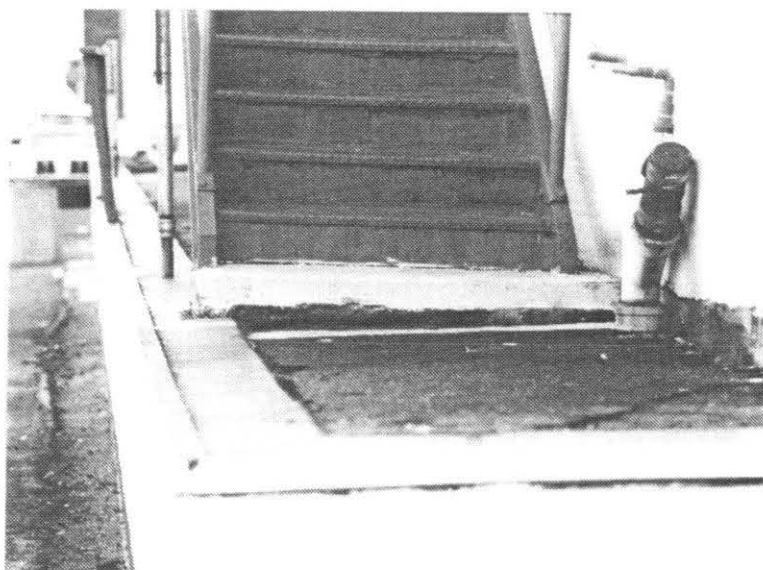
Settling on a loading dock caused by the 1989 earthquake.

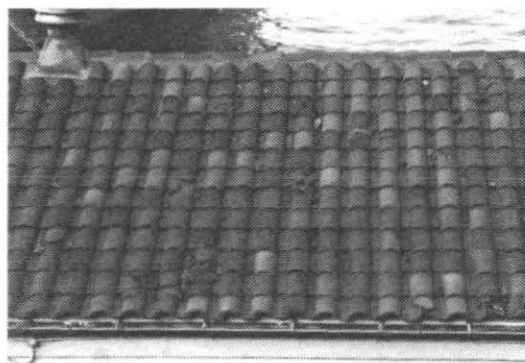
Tiles which no longer retain their original form due to cracking and displacement.

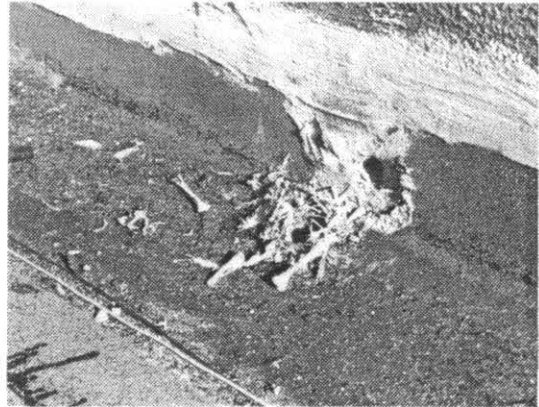
Drains in which debris restricts or stops normal rain water flow are designated as obstructed. Typical obstructions were feathers, bones, and pigeon droppings.

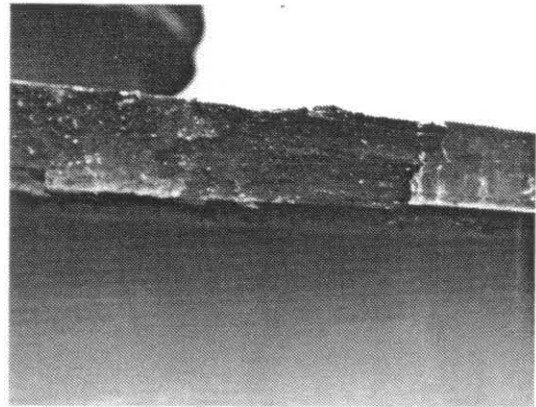
Failed Membrane

Failed Membranes are identified by bubbles, cracks, and areas of loose material.

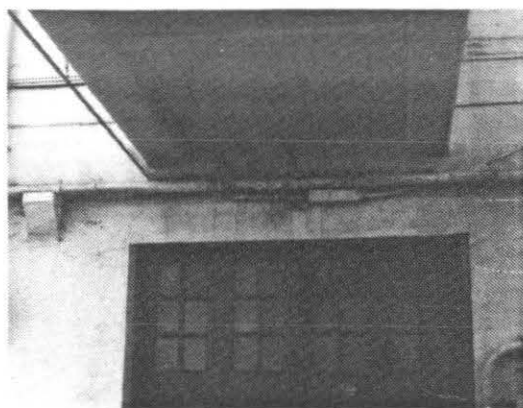
Bird debris is defined as any material which has produced soiling on adjacent materials due to the presence of pigeons. This may include, but is not limited to nests, bones, feathers, and pigeon droppings.

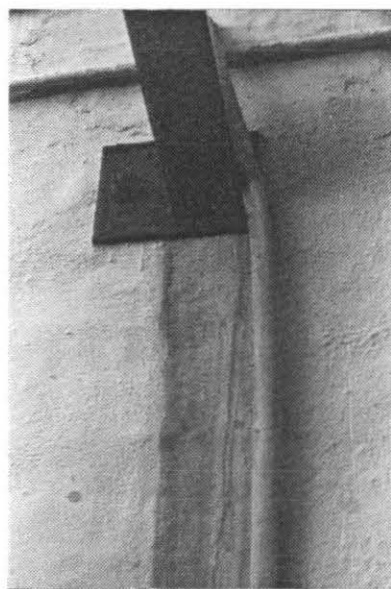
*Biological Staining*

Biological growths producing dark green to black stains on the concrete.

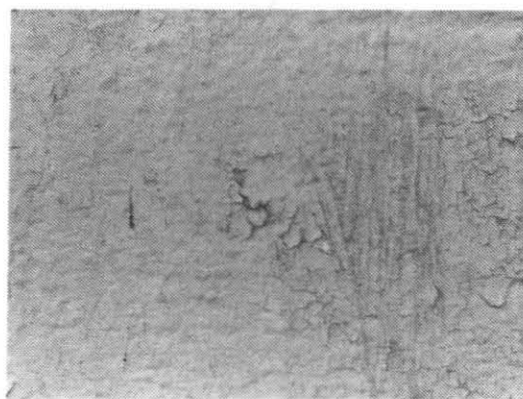
*Ferrous Staining*

Ferrous staining is staining of the concrete surface due to the oxidation of ferrous metal adjacent to, or imbedded in the concrete.

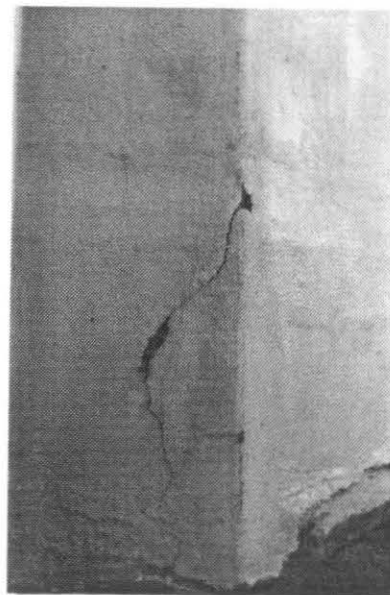
CRACKS, INCIPIENT SPALLS AND SPALLS are three conditions typically caused by corrosion jacking of reinforcing bars or imbedded steel anchors. Corrosion jacking is the increase in dimension that ferrous metals undergo during oxidation due to the presence of moisture. Iron oxide (rust) may expand up to eight times the thickness of the original metal. The increase in size exerts great pressure, leading to the rupture of the surrounding materials.

Cracks are fissures in the material of random width and length. A limited number of cracks were observed which varied in severity, and typically ran parallel with the building edges and window and doorway openings.

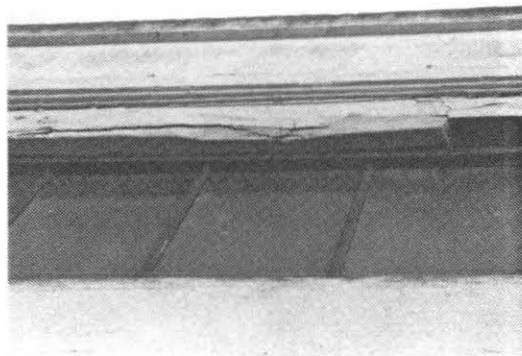
Incipient Spalls

Incipient spalls were noted on all elevations of the pier buildings, and at random locations on other structures primarily at window and door openings.

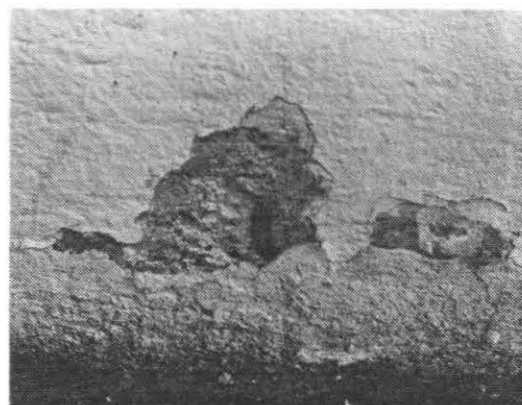
Spalls are losses in the concrete surface. Frequently, exposed reinforcing bars are visible in the spall area. Although spalls were observed on all elevations of the buildings, the most severely affected area was on the west elevation of Building 319.

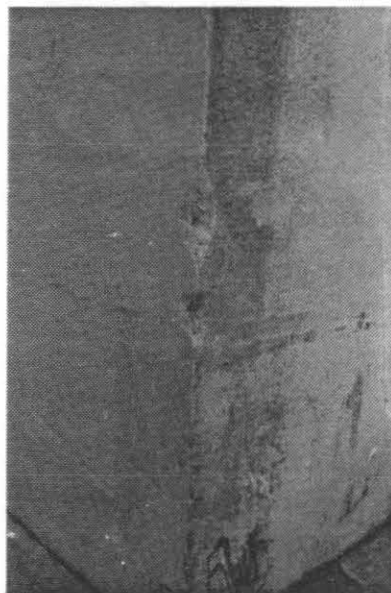
Impact Losses

Losses due to objects striking building, primarily at corners.

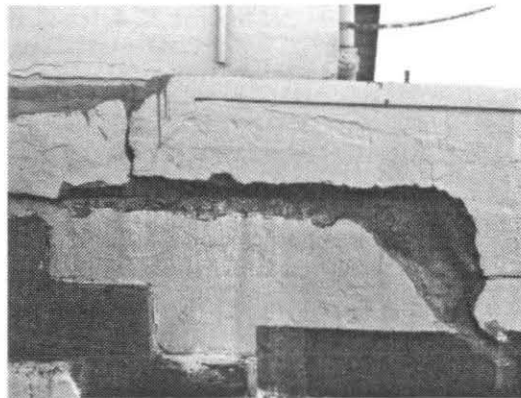
Displacement

Large cracks with corresponding displacement of walls and sinking of decks were noted in the porch walls. This damage may have been caused or exacerbated by the October 1989 earthquake.

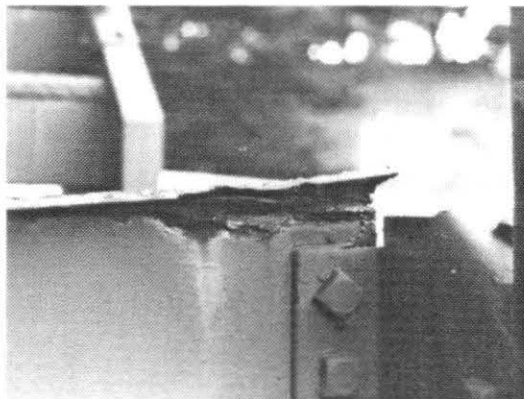
The deterioration of metal by chemical or electrochemical reaction resulting from exposure to moisture, chemicals or other agents.

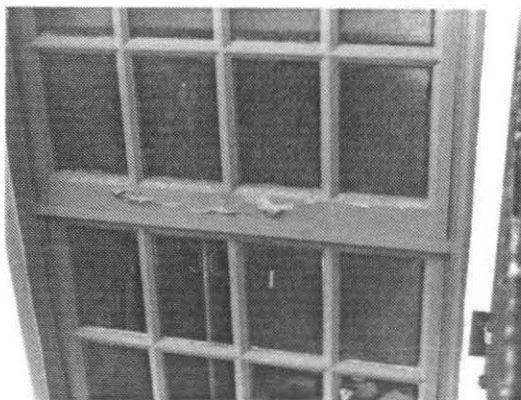
Failed Paint Coatings

Failed paint coatings are characterized by flaking and loss of adhesion.
